“Better than new”: refurbishes an opportunity to lift standards

A dilapidated Art Deco apartment block in central Wellington is resurrected, thanks to a committed new owner and expert advice.

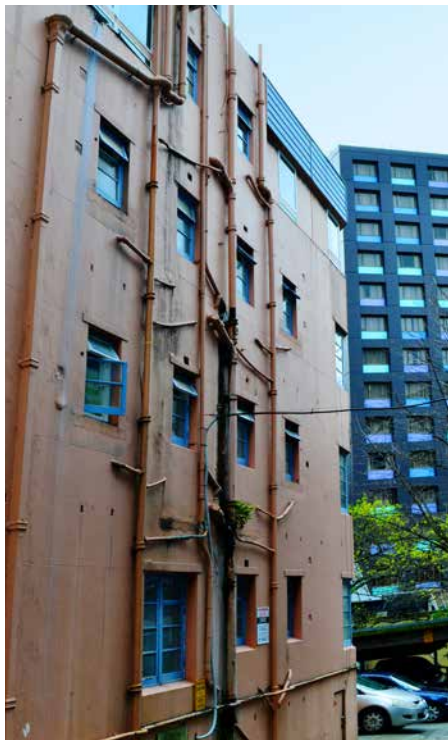
Plumbing issues prior to the refurbishment

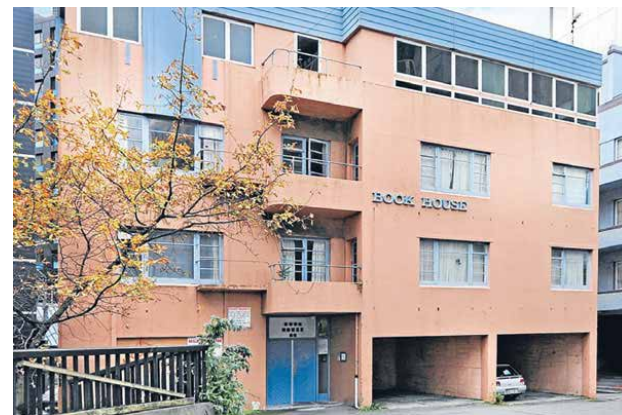
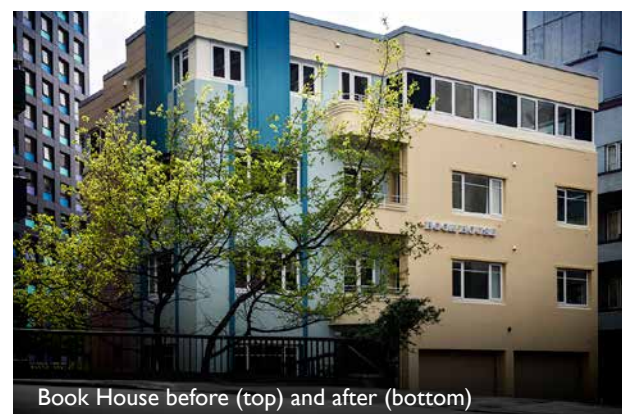
Book House before (top) and after (bottom)

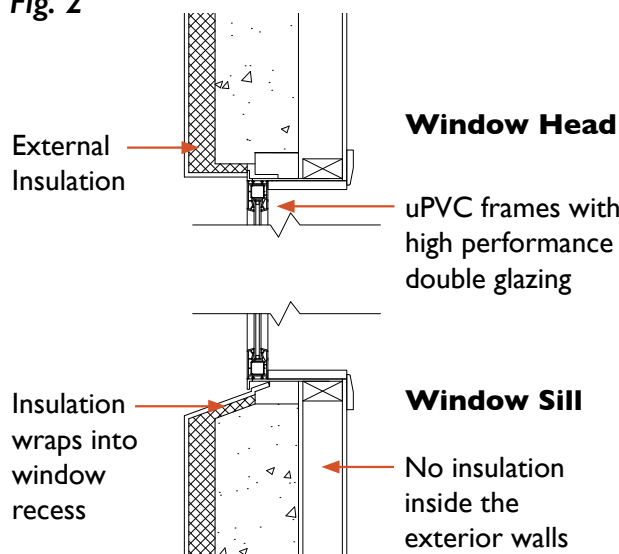
Fig. 2

Section of typical window head and sill showing the external insulation wrapping into the opening (no internal insulation). This creates concrete walls and window surroundings that are warm and dry, everywhere.

The timber windows were all replaced with new, double-glazed units. The thermally-broken frames were made in New Zealand from uPVC; the glass has low-e coating and argon fill. This improved the insulation value of the glazing by 150%. This was particularly important on the added top floor, which has extensive glazing. The new windows, as per the original design, are set back into the block walls and provide ventilation in accordance with the Building Code. Insulation was returned to the window frames (see Fig. 2), meaning no thermal bridges and no risk of mould.
